**THIRD FIVE-YEAR REVIEW REPORT FOR
VINELAND CHEMICAL COMPANY SUPERFUND SITE
CUMBERLAND COUNTY, NEW JERSEY**

**U.S. Environmental Protection Agency
Region 2
New York, New York**

This is the third FYR for the Vineland Chemical Company Superfund Site (Site), located in the City of Vineland, Cumberland County, New Jersey. The U.S. Environmental Protection Agency (EPA) is preparing this five-year review pursuant to the Comprehensive Environmental Response, Compensation, and Liability Act (CERCLA), as amended, 42 U.S.C. §9601 et seq. and 40 CFR 300.430(f)(4)(ii), and in accordance with the Comprehensive Five-Year Review Guidance, OSWER Directive 9355.7-03B-P (June 2001). This report will become part of the Site file.

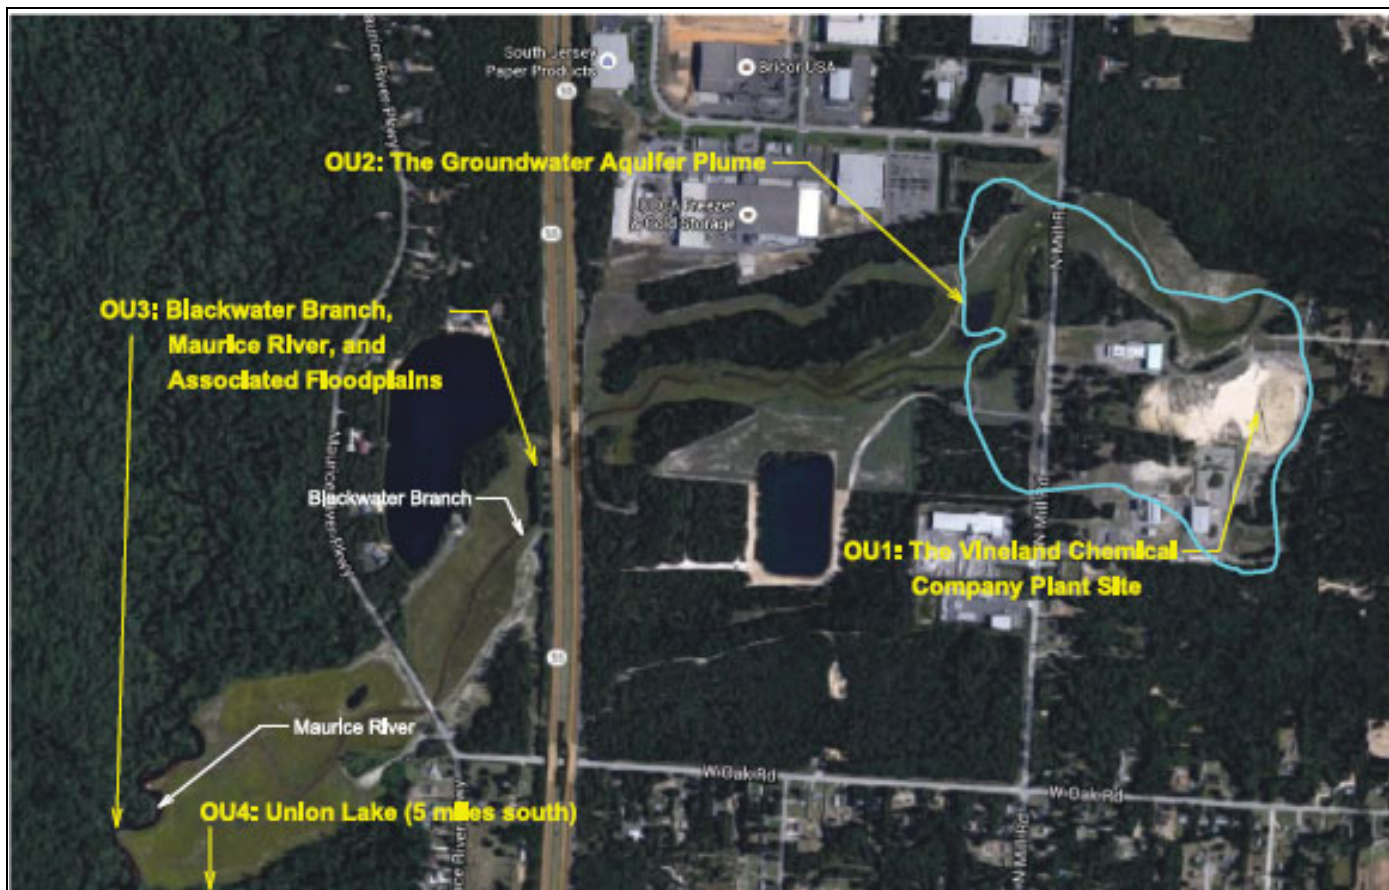
Figure 2: Operable Units

The ROD was signed on September 28, 1989, which divided the site into four OUs (Figure 2) and selected a remedy for each of them. The Remedial Action Objective (RAOs) and selected remedy for each OU as described in the 1989 ROD are as follows:

As noted above, the remedies for the Vineland Chemical Company are being implemented in four discrete phases (see Figure 2). OU1 and OU2 have been implemented. The Blackwater Branch portion of the OU3 that involved the excavation of the floodplain soils and the restoration of the Atlantic White Cedar wetlands has been implemented, whereas the Maurice River portion of OU3 will be implemented in later phases so that up-gradient contamination from another Superfund site can be addressed first. Under the OU3 ROD Amendment, the air sparge has been implemented and is currently operating near Area A (see Figure 4).

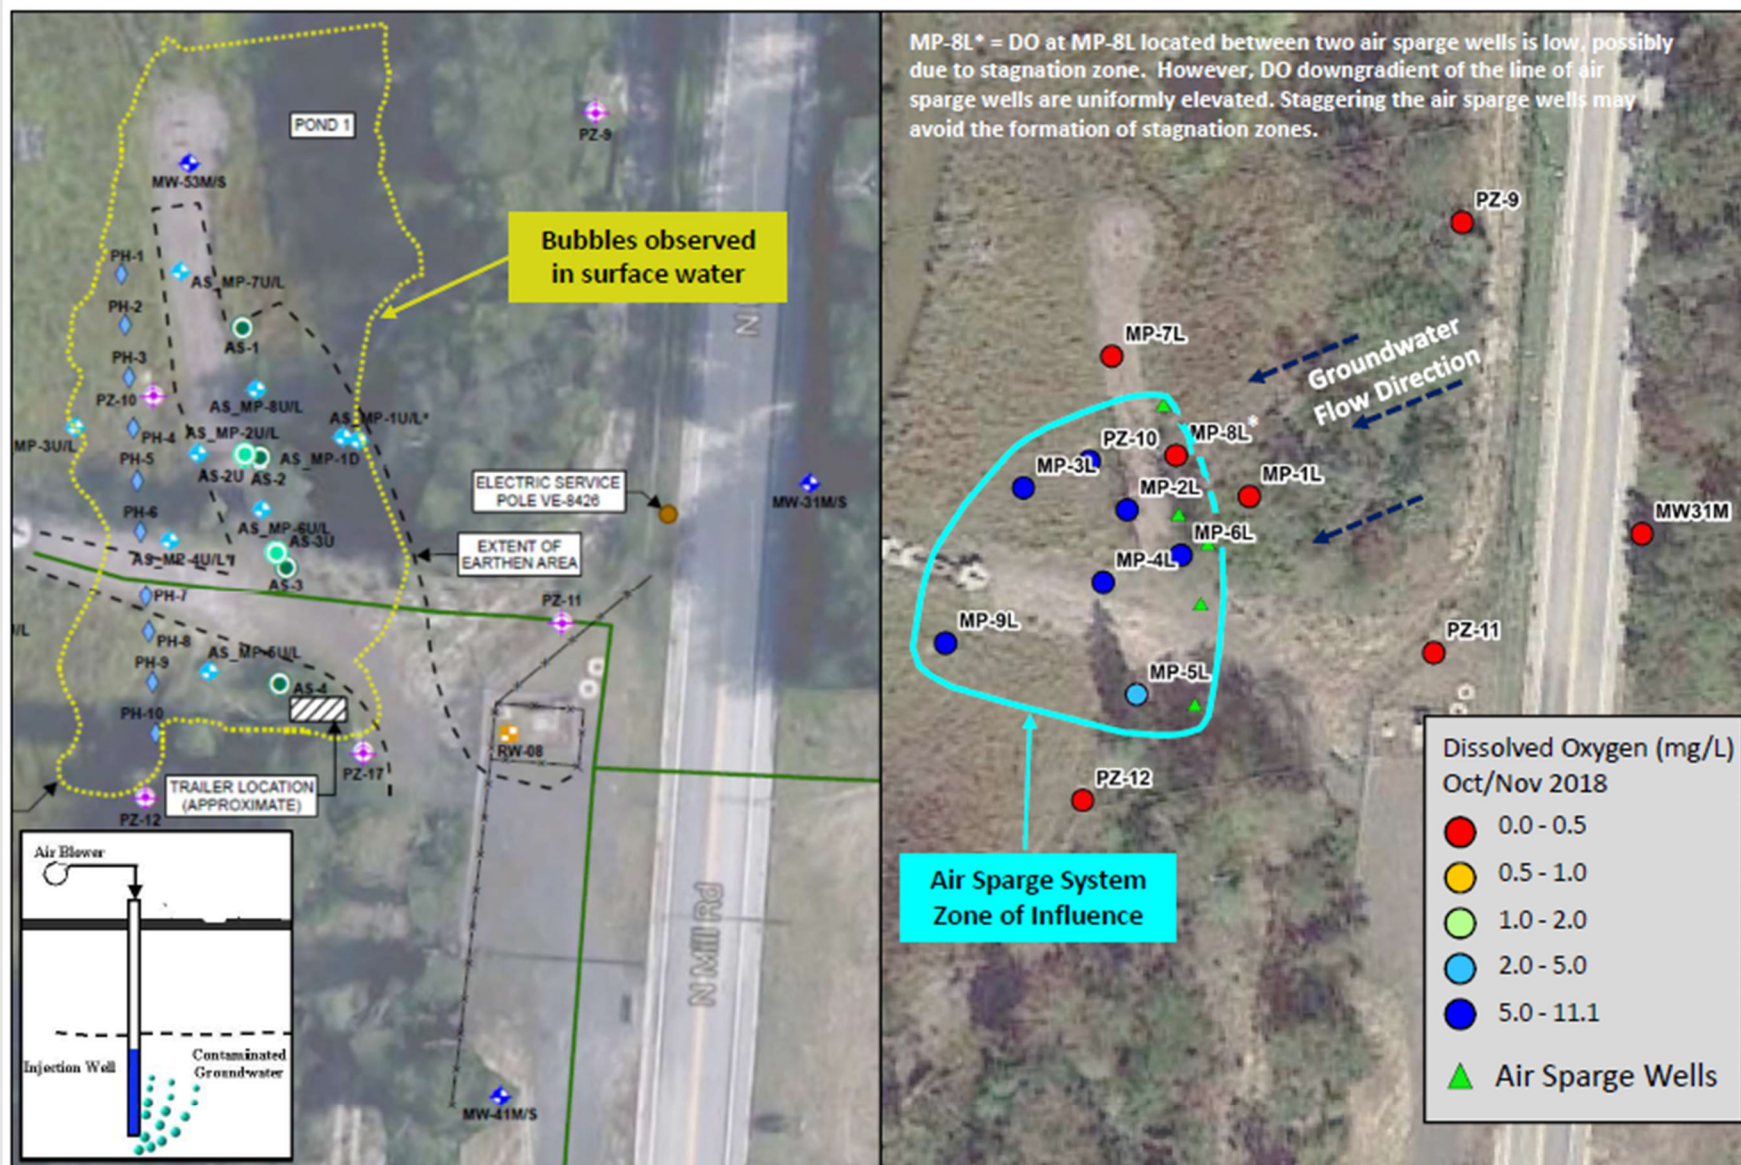
Figure 5

Air Sparge Zone of Influence - AS-1 through AS-6
Operating at ~ 65 scfm
Surface Air Bubble Observations and Zone of Influence
